INSPECTION REPORT

Sample Inspection On-line Inspection	Pending	
Summary Section	Service Number: M	IXKS024071201
Product picture	Product Name	Creeping mat
	Item number	
	P/O number	
B B B	Quantity	3000 sets
	Client name	
	Supplier name	Yiwu Jietai ********
	Inspection date	July 10, 2024
	Arrival time	09:00 Mar 03, 2024
	Departure time	17:00 Mar 03, 2024
	Inspection location	Yiwu,zhejiang
	Inspector	Mr liao

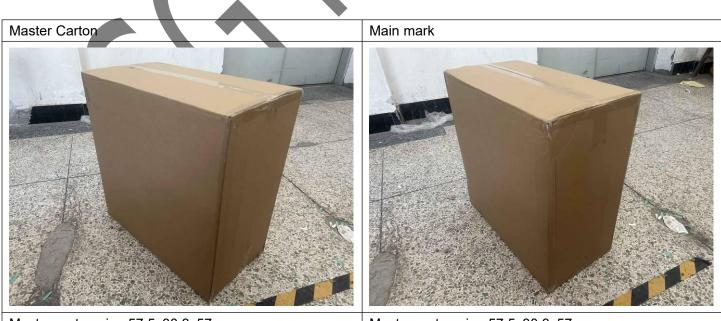
Master carton size-57.5x30.3x57cm

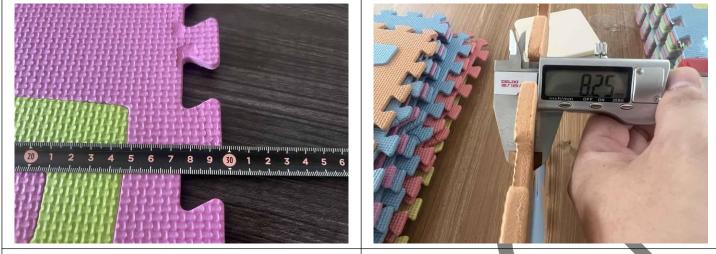
Product size :29.5x29.5x0.825cm

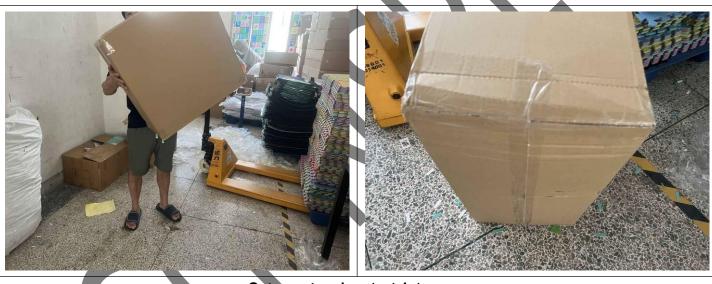
Outer carton drop test-1ctn-pass

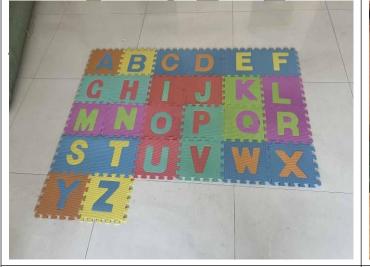
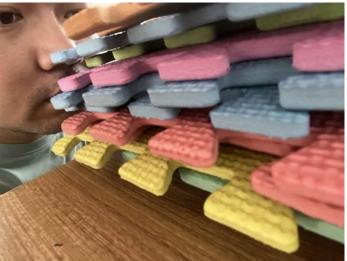
Function test-5pcs-pass

Odor test-125pcs-fail

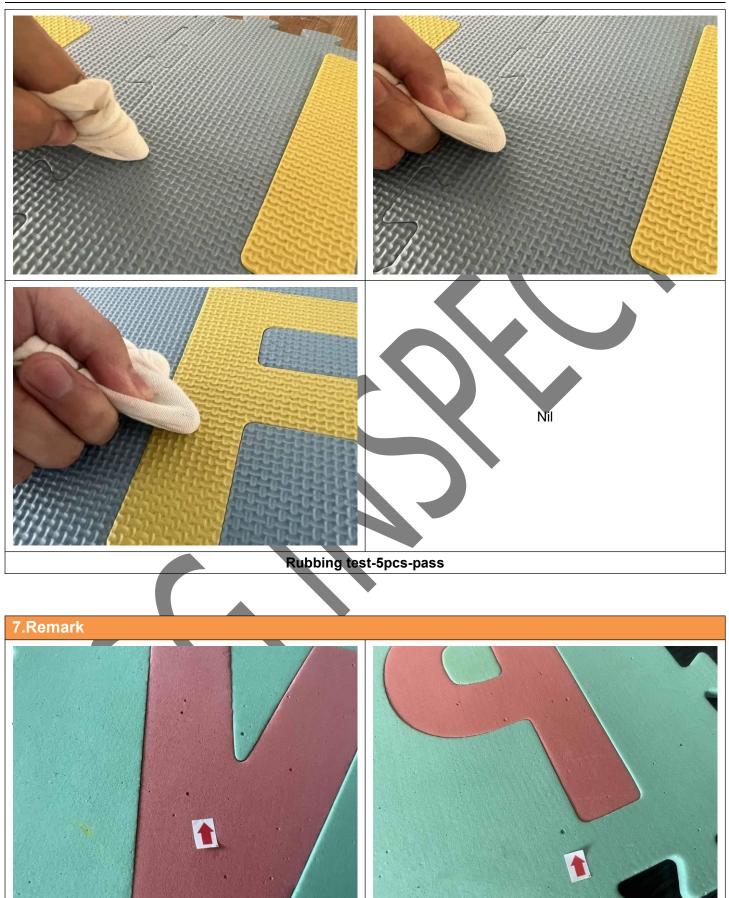
Remark2:Actual found 100% of inspection samples have holes on backside

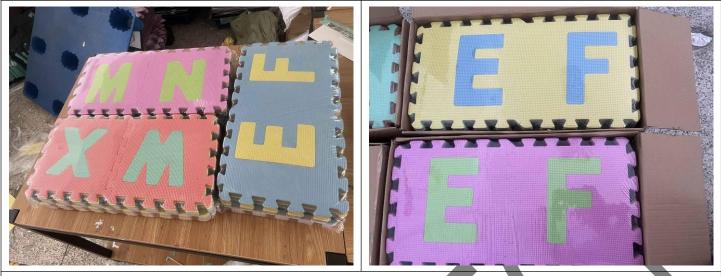
Remark4: The color of each letter was random, and the packaging of each letter was random.
